Typical Timber Frame Cons:
 100 Brick External Leaf
 60 Cavity
 Breather Membrane
 Dressed over D.P.C. on
 18 WBP Plywood with
 100x175 Timber Frame Inner leaf with
 100 Quilt Insulation
 Vapour Barrier on
 12.5 Internal Plasterboard

DETAIL 143: TIMBER FRAME BRICKWORK

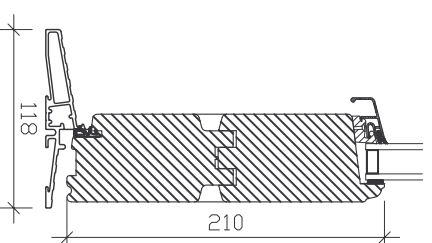
JAMB:
OPENING SASH

Profile Sections
