CARLSON

DETAIL 153: TIMBER FRAME BRICKWORK

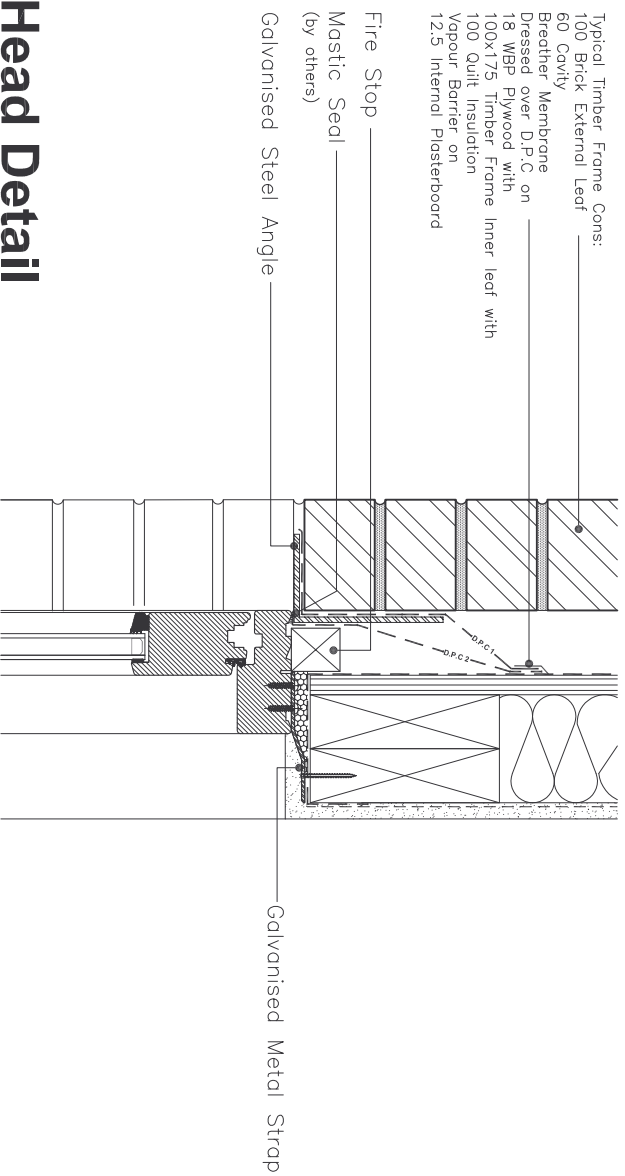
Typical Timber Frame Cons:
 100 Brick External Leaf
 60 Cavity
 Breather Membrane
 Dressed over D.P.C. on
 18 WBP Plywood with
 100x175 Timber Frame Inner leaf with
 100 Quilt Insulation
 Vapour Barrier on
 12.5 Internal Plasterboard
