Typical Timber Frame Cons:  
 100 Brick External Leaf  
 60 Cavity  
 Breather Membrane  
 Dressed over D.P.C on  
 18 WBP Plywood with  
 100x175 Timber Frame Inner leaf with  
 100 Quilt Insulation  
 Vapour Barrier on  
 12.5 Internal Plasterboard

DETAIL 163: TIMBER FRAME BRICKWORK

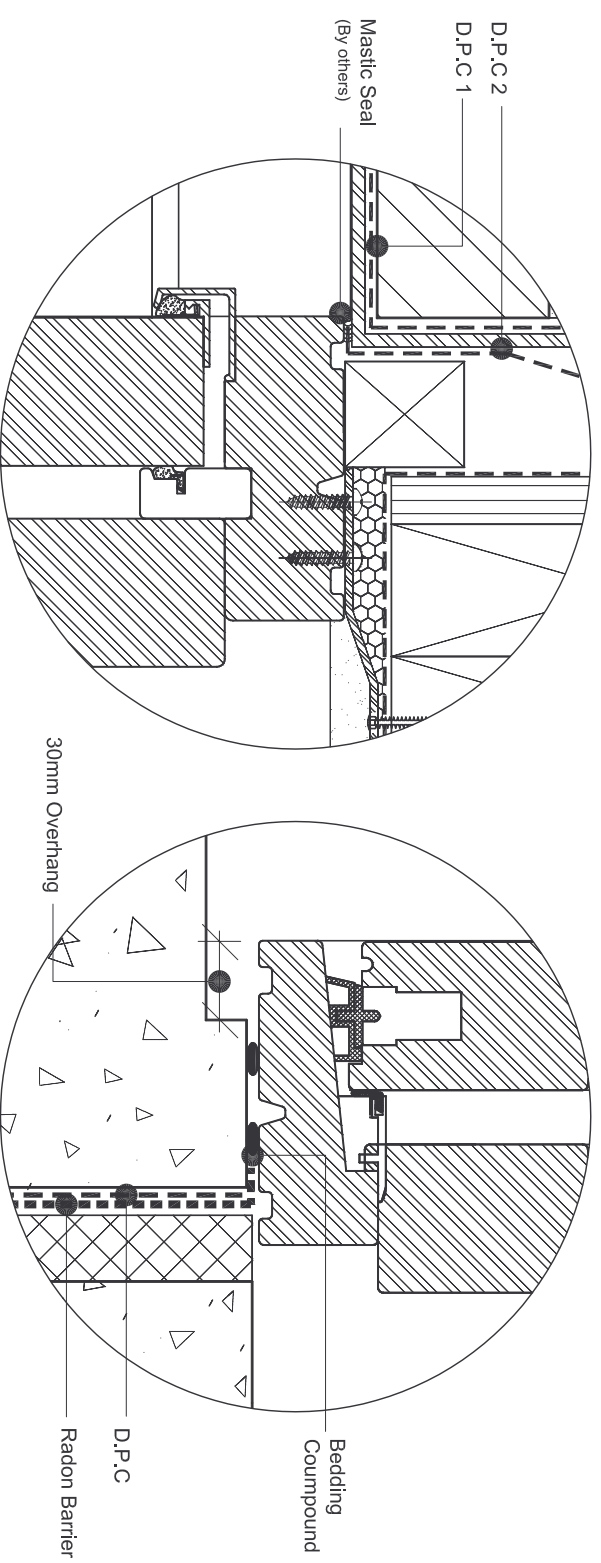
Detail A

Detail B
